# Manhole Inspection Summary

Manhole # S23M1\_003MH

Insp Date: **6/16/08 8:24 AM**

**Location** Address: **3100 Annapolis Rd.**

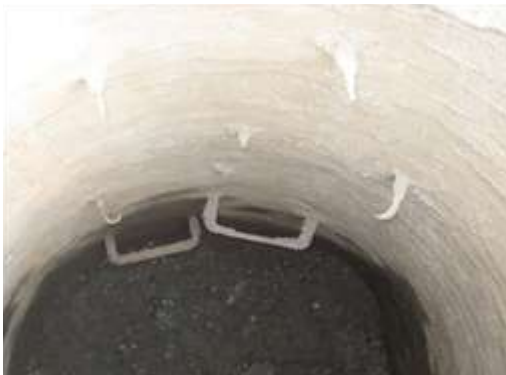
Steps

Count: **2** Missing: **3** ☒ **Corroded**

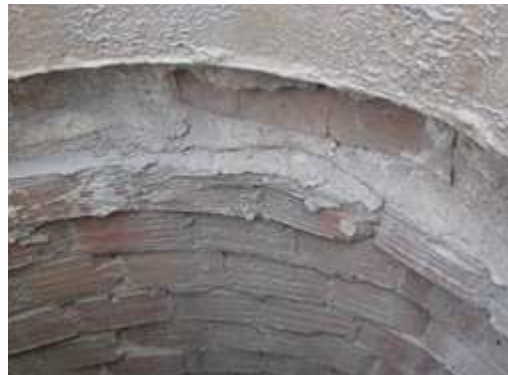
Defect 2

Condition: ☐ Sound ☒ **Cracked** ☐ Root Intrusion ☐ Loose Brick ☐ Deteriorated

Cracked Chimney.

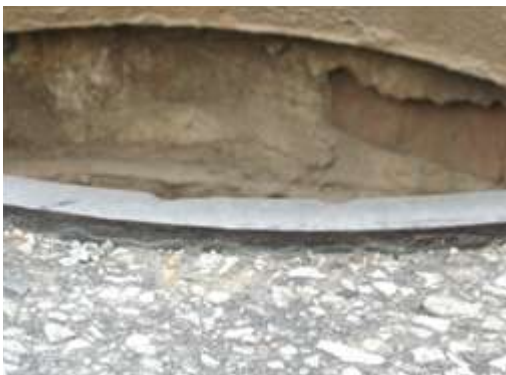
Defect 1

Diameter: **24** (in.) Length: (in.) Dist A/B Grade: **1** (in.)

Frame above the grade.

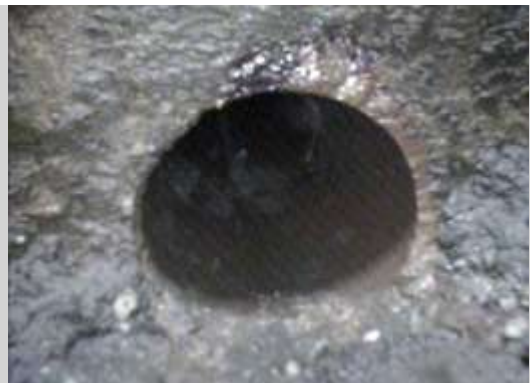
12 O'Clock Outflow

8 in. Circular Gravity Sewer  
Pipe Out @ 12 O'Clock
